MEMOIRS
OF THE
GEOLOGICAL SURVEY OF INDIA

THE KANGRA EARTHQUAKE OF 4TH APRIL, 1905

By
C. S. MIDDLEMISS, *B.A., F.G.S.*
Superintendent
Geological Survey of India

Published by order of the Government of India
1910
Reprinted 1981

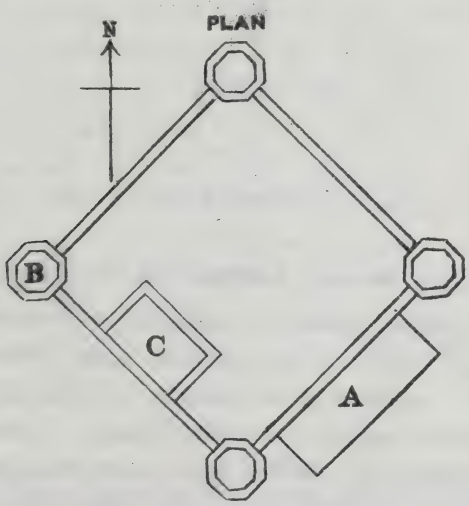
FIG. 1.

The fort stands on an isolated ridge above Rehlu village and 200—300 feet above the latter. (See plate 2, fig. 1.) Its site also is composed of remade morainic material, *i.e.*, clay and large boulders of granite, all derived from the snowy range above. The hill behind Rehlu Fort is composed of Nahan sandstone and Siwalik conglomerate, and there are cracks in the steep hillside running about N. W.—S. E. above the fort. These, I think, are only surface cracks, there being no evidence of anything but motion with gravity. The fort is a massive structure, standing four-square with corner octagonal towers.

A great part of the N., E, and S. towers had fallen. Also the house where the Rajah Azimulla Khan with one uncle, five cousins and twenty-eight retainers perished, A. The tower B still stood, but was badly fissured. C = high keep, not fallen. The N. E. wall of the fort showed a horizontal crack (which also passed through the towers) coinciding with the lowest shooting platform above where the wall was thinner and loopholed.

In the centre of this wall a great hole had been made. The wall just failed to rock over to the north-east.

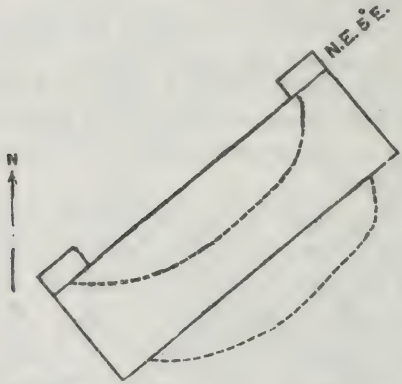
FIG. 5.—The dotted lines indicate fallen walls.

which presented a cut face of soft rock behind and above, and a remade bank or terrace with retaining wall in front and below. The long axes of the buildings varied considerably in direction, but prevailing directions were N.—S. and N. E.—S. W., with the downward slope towards the E. and S. E., respectively. In all cases the two long walls had rocked over generally as a whole, in the downhill direction, with the exception of the portions immediately connected with the stone-built end walls, which latter stood (fig. 5). The heavy slate roof naturally collapsed with

the walls. All the sun-dried bricks lay approximately in position on the ground, but each separated from its fellows by the shock of the fall.

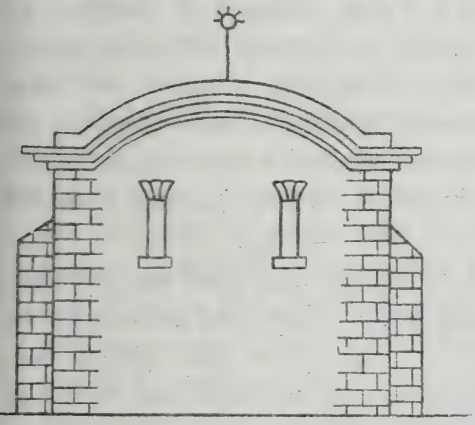
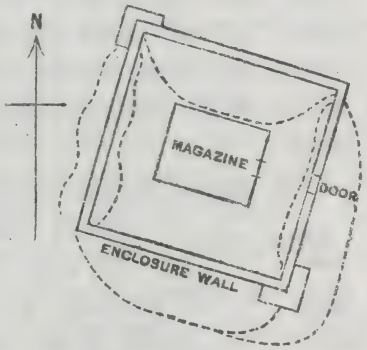
FIG. 6.—Magazine elevation.

The Magazine stands on an isolated little knoll at the S. W. end of the cantonment ridge, and consists of a central square room very strongly built of well dressed stone and lime mortar. It possesses a strong and heavy arched masonry roof. The whole is surrounded at a few yards distance by a well built stone enclosure wall. The enclosure wall all fell more or less, whilst the building itself was undamaged save for a few cracks.

The enclosure wall facing S. by W. fell outwards quite flat, the wall facing E. by S. also fell outwards but rather inclined to the south, a little of the debris being inside. The N. by E. wall fell inwards as a whole. The W. by N. wall fell irregularly partly inwards and partly outwards. This seems to give a general direction of shock about S. S. E. or S. Although the magazine was intact I was informed that the ammunition boxes inside were found tossed about.

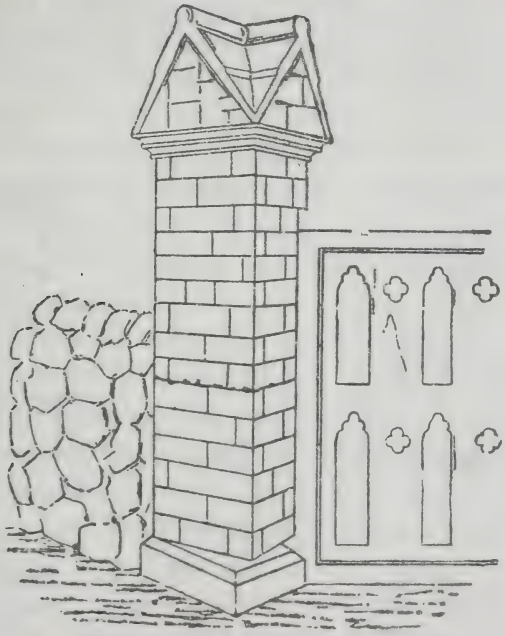
FIG. 9.

The gate pillars at the W. entrance are about 10 feet high. One of these was twisted on its base through an angle of 11° in the opposite direction to the hands of a watch just as in the case of the tombstone. (Figs. 9 and 10.)

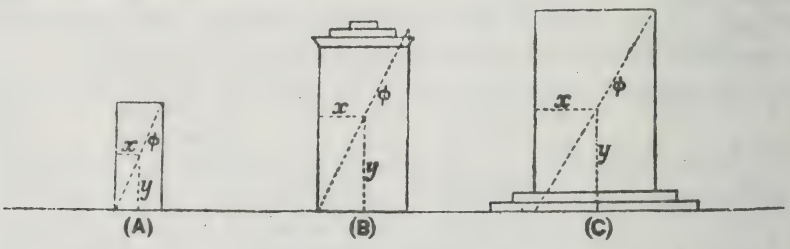
FIG. 13.

The old European cemetery at Kangra Bhawan lies in the middle of a flat plain, and at the time of my visit exposed a number of rectangular masonry pillars, overturned or broken with more regularity of direction than I have seen elsewhere (see fig. 13). They comprise:—

(A) Two small, rectangular upright tombs, 3 ft. high, by $1\frac{1}{6}$ ft. square. Fallen as a whole towards N. E.

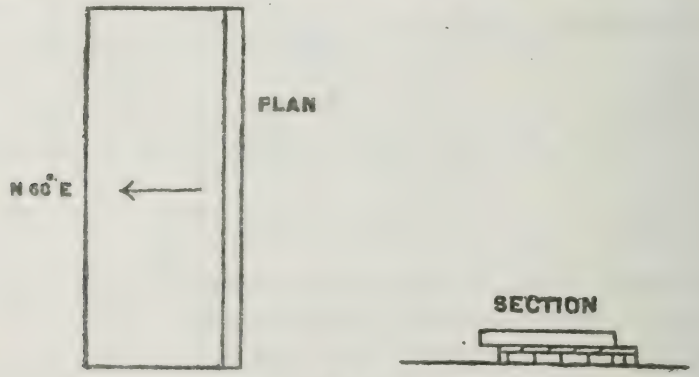
Fig. 14.

In the same cemetery also a large flat slab, 4 ft. 10 in. by 2 ft. and 4 in. thick had moved 4 in. towards N. 60° E. (Fig. 14.)

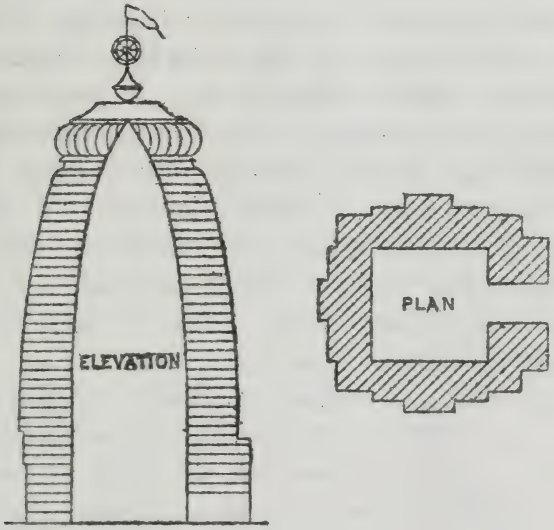
FIG. 15.

A pair of Suttee pillars, about 6 ft. by 3½ ft. near the cemetery had fallen E. by N. They were situated on a little ridge, but fell diagonally to its length and to cracks in the ridge. There were also a number of other little temples and shrines generally in the form of simple *sikras* like that depicted in pl. 2, fig. 2, which have been tipped up at an angle, shifted horizontally, or otherwise moved. The following vertical section (after Fergusson) of a typical *sikra*, or stumpy convex spire belonging to early Hindu temple art, will show the general nature of such rather stable and well built structures. They are always erected over idols or other representations of the deity and are very numerous in Kangra and the valley parts of Kulu. They are about 15 to 20 ft. high. (Fig. 15.)

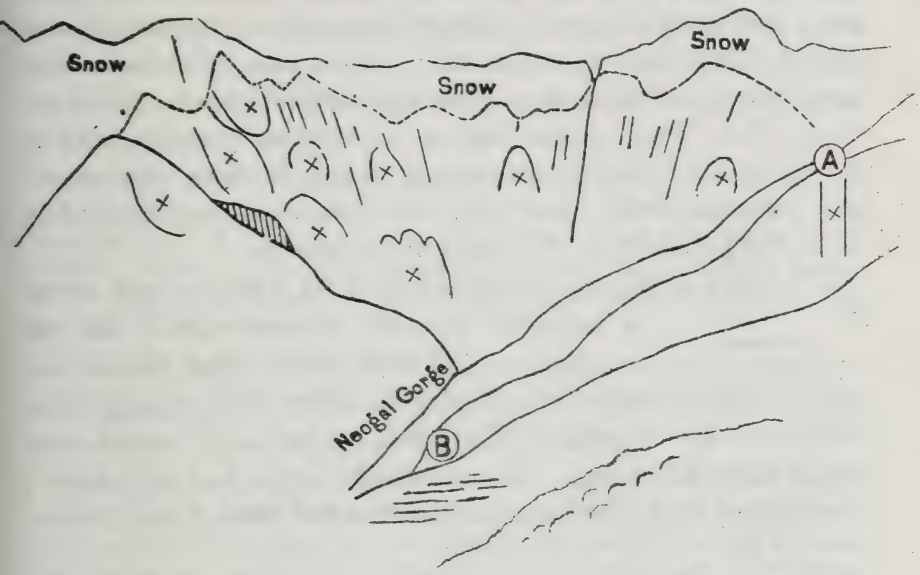
FIG. 16.

we could see and watch clearly the scarred surface of the rock from which the puffs of dust arose at intervals (fig. 16). It was evidently a

Chief slips marked (X).

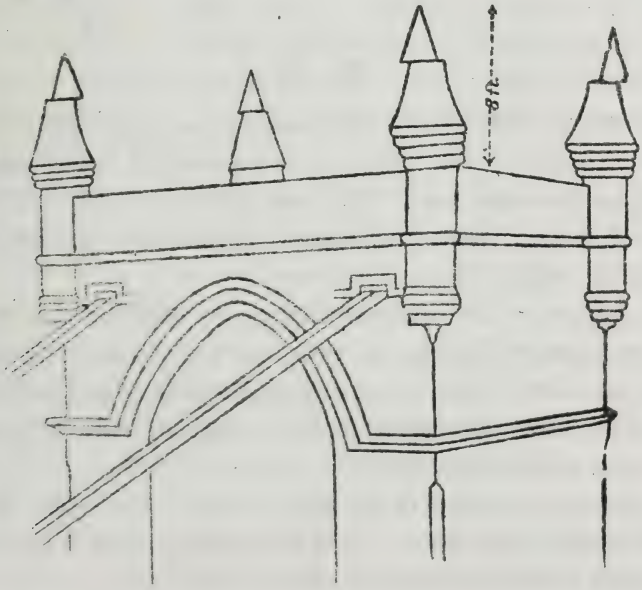
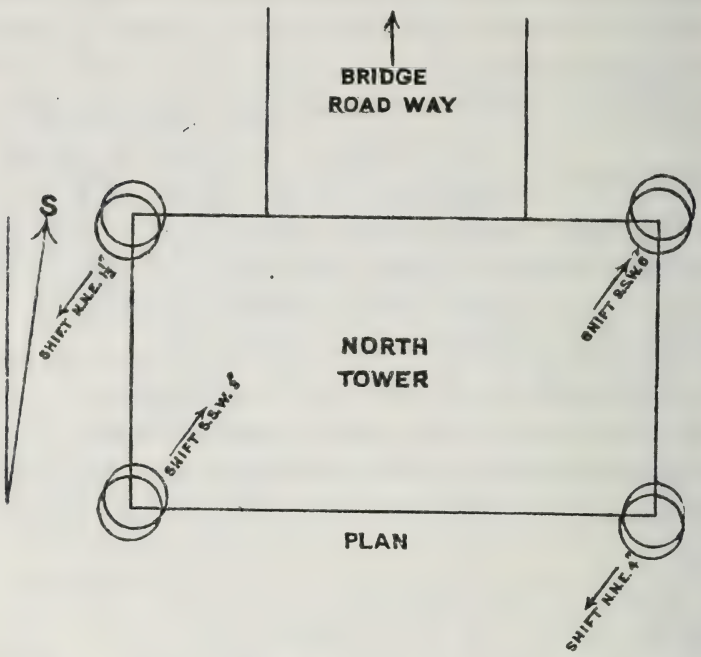
FIG. 17.—View from N. W.

The suspension bridge at Mandi across the river, a fine structure built in 1877 by Rajah Bige Sen, was intact, and had not suffered more than a good shaking. The towers, however, rising 25 ft. high above the roadway, and 50 ft. above the river-level, were furnished with 4 flying turrets one at each corner, each finishing in a pinnacle. The top conical stones of these pinnacles had been shifted horizontally along the rest of the pinnacle without falling, in the manner shown in the sketch and plan below, which represents the northern tower. (Figs. 17 and 18.)

From the southern tower all the capping stones had fallen, except in the case of the S.-E. turret where the top stone and lower courses had shifted opposite ways in a N. N. E.—S. S. W. direction. In the case of the N. E. turret 2 courses of masonry below the conical capping stone had also fallen.

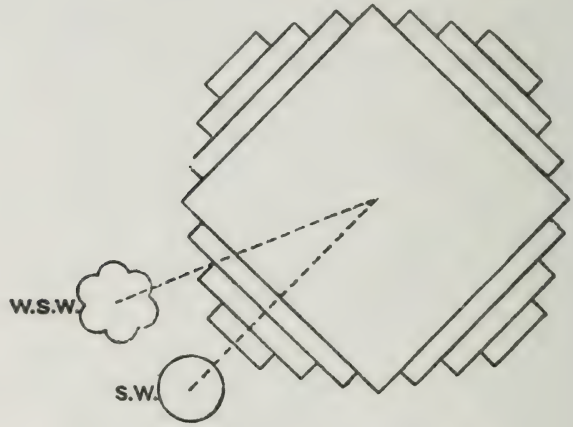
FIG. 19.—Plan.

The palace being rather more strongly built had not suffered quite so much, the temple moderately so (see pl. 13, fig. 2). The lower town and bazar, situated below the high level plateau, had been considerably ruined, though much had been repaired by the date of my visit (19th May). A stone-built Shiva temple, like that at Bajaura, had stood but the top stone, the *amalaka*, had been thrown one portion S. W. and one W. S. W. (See fig. 19.)

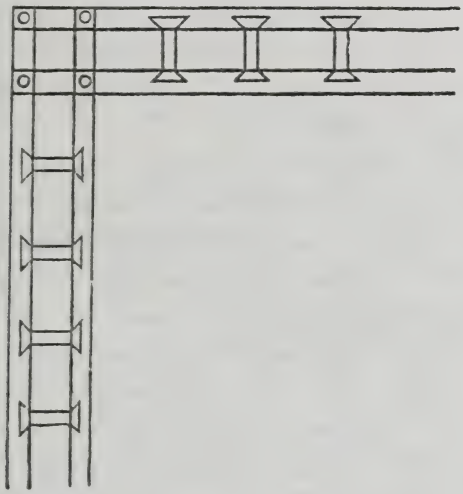
FIG. 21.

The method of inserting the wood-bonding requires, however, further illustration. In houses of ordinary pretensions this wood bonding takes place at vertical intervals of from 3 to 5 feet. Two parallel beams are laid along the layer of masonry, one on the inside and one on the outside. At the end of one wall they are crossed by the beams of the wall at right angles, and wooden pins hold the crossings together. Cross-ties of wood, dove-tailed or tongued, similarly hold the two parallel beams in position at intervals along their length (fig. 21).

Usually rubble masonry, or roughly shaped blocks carefully packed together, occupy the interspaces and form the next courses until another wooden course is begun.

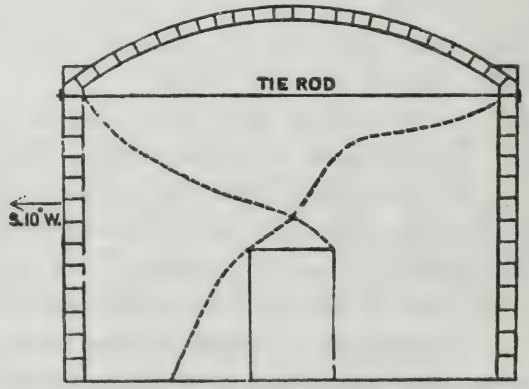
FIG. 24

Jail. The worst-damaged building is a long barrack aligned N. 80° W., and built of boulder masonry tied with burnt brick. Only slight cracks show in the longer walls, but the end walls are badly fractured diagonally, as shown in fig. 24.

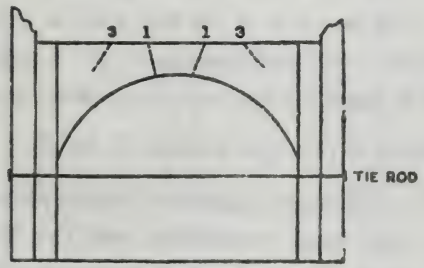
FIG. 25

On the east face the porch has slightly separated from the main building. Of the arches in the porch that facing east is cracked vertically at the crown, whilst in those at right angles the cracks hade east at about 30° from vertical. The main east wall shows a crack hading N. at 45°, and also slight irregular fracturing. A well pronounced horizontal crack runs along the wall at the level of the spring of the roof. In the interior the four corners are slightly cracked. The roof and ceiling are partly carried by a series of five tranverse arches. Everyone of these arches is cracked, and as they are somewhat flat and are said to have been built without key-stones, would have collapsed, but that they are held to the main walls by iron ties. The nature of the damage to two of these arches is shown in fig. 25.

Apparent direction of principal motion N. 20° E.—S. 20° W.

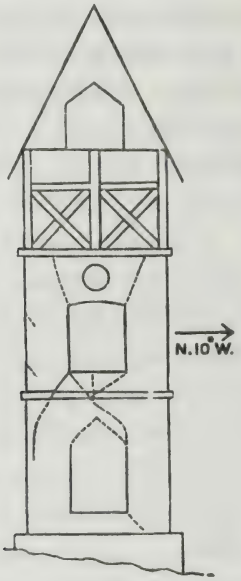
FIG. 27.

This group of buildings is constructed partly of limestone blocks, and partly of brick. Only one of the buildings has suffered severely. This is a brick erection of three stories, and is aligned N. 55° W.—S. 55° E. At the S. E. end there are square flanking towers, the walls of which make an angle of 135° with the walls of the main structure. Every face of these towers is badly fractured in all stories except the highest, which is a brick-filled frame of wood, and probably yielded to the shock. The cracks are almost entirely structural as shown in sketch (fig. 27).

The most important cracks in the main building run N.W.—S.E., but chiefly follow lines of weakness such as bay windows. In a wing running N. 35° E. rounded portions of the walls are fractured vertically on lines joining window openings, and a few corners of rooms are slightly cracked. In a wall running N. 55° W. a crack hades S. E. at 30°,

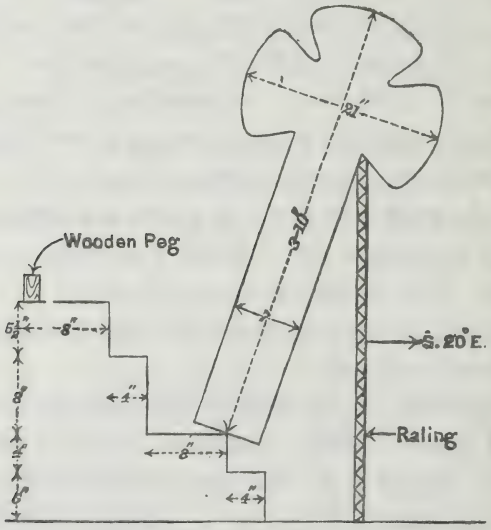
Fig. 28.

An ornament on the top of Major Wheatley's tomb fell to N. 65° E. A sandstone cross, erected to the memory of Henry Earl Read, was displaced and now leans against the enclosing railing at a point S. 20° E. of its original position (fig. 28).

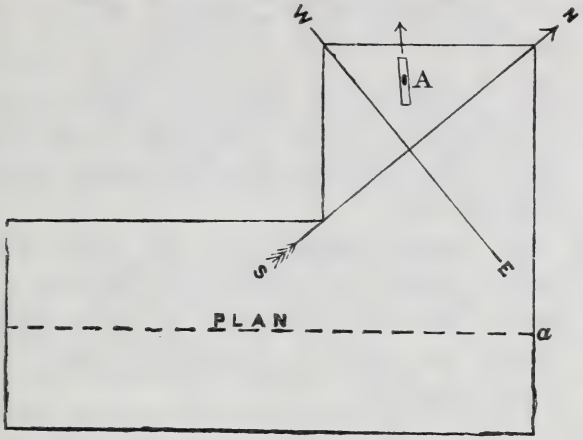
FIG. 29.—A = slit in which pendulum swung.

Mr. Hallowes has described the interesting case of the clock on the Methodist Church, Mussoorie. This clock which was fully wound up, had stopped on April 3rd (the day before the earthquake) owing to the striking gear getting out of order, but on the morning of the 4th it was found to be going, having been restarted by the earthquake. As the pendulum was only free to swing in a slit running N. 50° W. which was very nearly at right angles to the long axis of the building as a whole it seems likely that

the building rocked as a whole about that axis and imparted the necessary swing to the pendulum. (See fig. 29.)

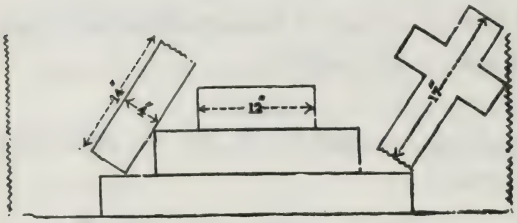
FIG. 30.—Scale $\frac{1}{20}$.

A cross erected to the memory of Curtis Martin fell to N. 18° W. (See fig. 30.)

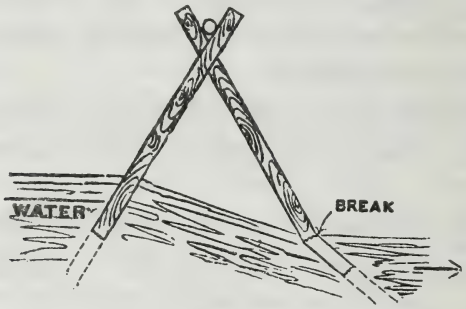
FIG. 31.

This is a boom across the Ganges about two miles above Hardwar. It courses N. 75° E., and is composed of wooden crates filled with stone, abutting one against the other. Three of these crates were broken on the down-stream side during the quake. The position of the break can be seen from the sketch (fig. 31), which represents the upper portion of the "band."

Probably the force causing the break is the resultant of the force of the current and the force due to the earthquake impulse.

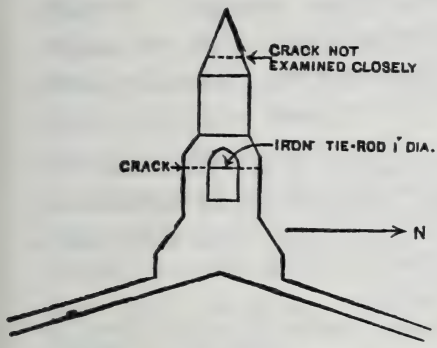
FIG. 32.—Scale 1 inch=20 feet.

nave. It is about 27 feet high and consists of a spire-capped square lantern carried on four pillars. (Figs. 32 and 33.)

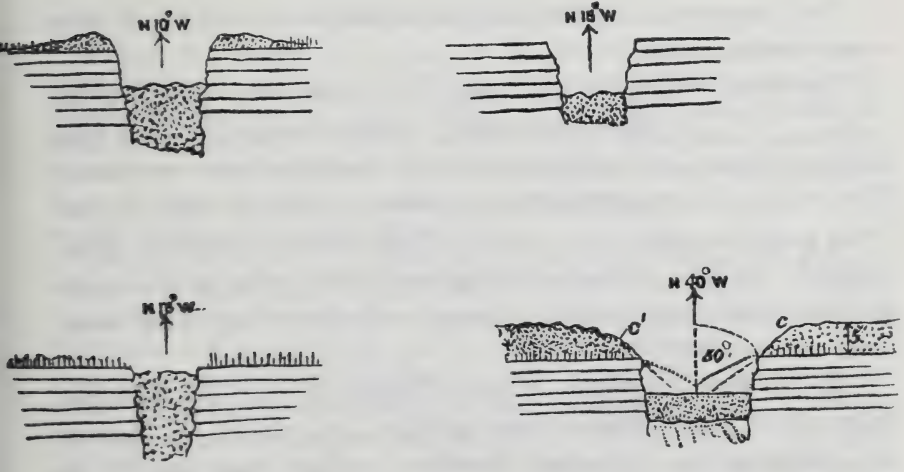
Fig. 34.

About $2\frac{1}{2}$ miles further east fissures of a similar character to those described above occur. Mr. Hallowes described them as lying between N.—S. and N. 60° W. and from 5 to 50 yards long, the greatest breadth being $1\frac{1}{2}$ feet. Most were filled with sand and water, and some had scattered sand in little mounds along their edges. (See fig. 34.)

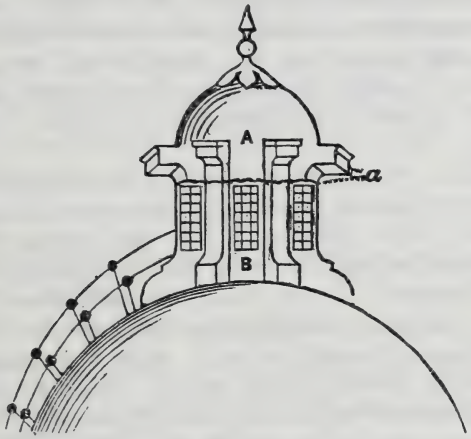
FIG. 36.

Mr. Hallowes found the Engineering College nowhere severely damaged, but the buildings lying N.—S. were much more cracked than those lying E.—W. A clock on a N.—S. wall stopped at 6-13 A.M. A small dome which surmounts the central dome was fissured horizontally at its base and entirely separated from the rest of the structure. (See fig. 36.)

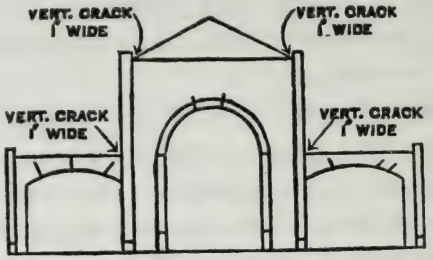
FIG. 37.

base. The damage provides strong evidence of motion across the building.

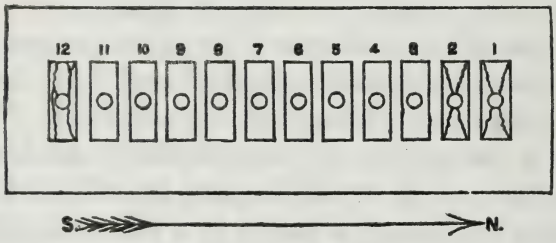
FIG. 39.

In Lahore Central Museum the roof of the long and lofty central room contains twelve separate barrel-arched ceilings of brick and plaster, each being perforated by a circular aperture in the centre for lighting purposes. The 1st, 2nd, and 12th ceilings are cracked, the 1st and 2nd diagonally, and the 12th more irregularly, but with a diagonal tendency. (See fig. 39.) This room lies due N. and S. In another room with the same bearings, one of a similar set of ceilings is cracked diagonally in the same way.

On the corners of the roof solid dome-like turrets of brickwork pierced by small arched doorways on the four sides, were severely shaken and cracked.

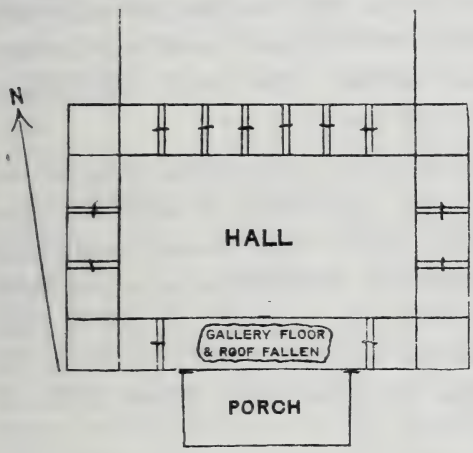
FIG. 40.

The Montgomery Hall is a large heavy building of which the main hall has suffered. This is a lofty room around which extends a gallery or internal verandah about 15 feet from the ground. On the south side of the building is a tall porch which has separated a little from the hall. Part of the roof over the gallery adjoining the porch has fallen upon and broken through the gallery floor beneath: this catastrophe was no doubt connected with the movement of the porch, which to some extent appears to have carried with it the wall of the building, in the oscillations, and to have thus drawn the beams of the gallery roof out of their sockets.

The capitals of the porch pillars are cracked, as are also all the keys of the arches over the gallery, as indicated in the diagram (fig. 40).

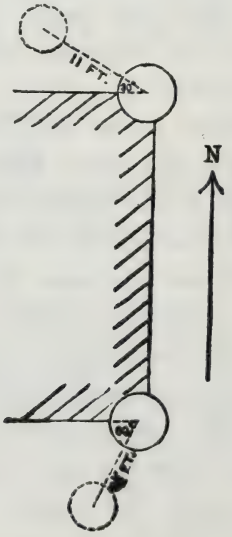
Fig. 41.

The height of the minarets was 40½ feet and the diameter of the more or less spherical cupolas was about 4 feet. The cupola on the S. was projected 8½ feet away from the centre of the minaret base, and in a direction S. 30° W. The cupola on the N. was projected 11 feet away from the centre of its minaret base, falling W. 30° N. It will be noticed that these directions are at right angles. (Fig. 41.)

The horizontal velocity of the N. cupola was thus 6·91 feet per second, that of the S. cupola, 5·55 feet per second. The resultant of these is 8·74 feet per second from E. 7½° N. to W. 7½° S.

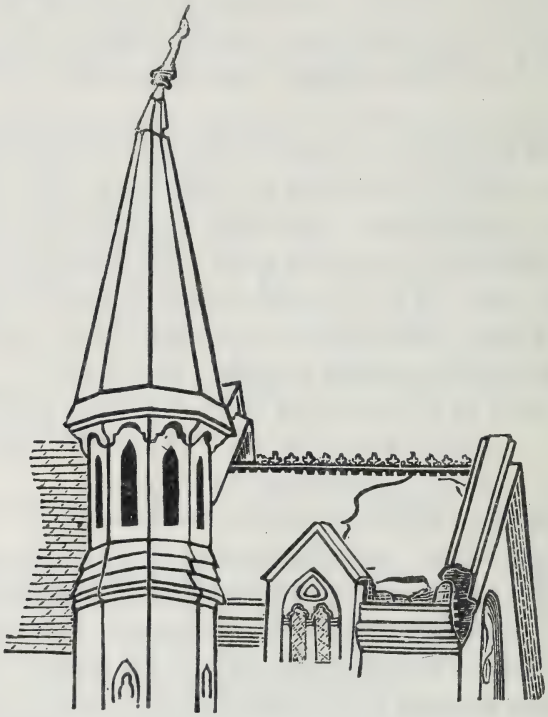
FIG. 42.

On the N. side of the western porch of the Church is a moderately tall belfry steeple bearing at its summit a stone cross, which is fixed to the steeple by an iron core through its centre. The cross and upper 4 feet of the steeple have been wrenched away from the lower part of the latter, but have been prevented from falling by the iron core. This, however, has been bent from the vertical so that the cross and steeple top are now leaning exactly towards S. W. (fig. 42).

In the W. wall of the adjacent western porch, near the N. W. corner is a long wide crack running vertically downwards. The edge of the gabled porch roof at this corner has been shattered, and a little brickwork has fallen.

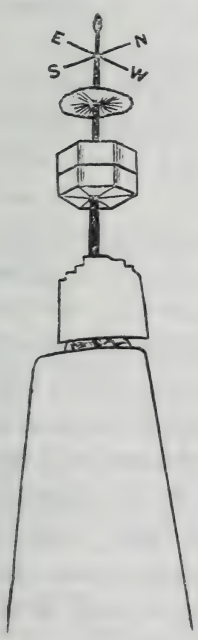
FIG. 43.

The Clock Tower (see fig. 43) is a modern structure of red-brick, covering a small area, but 175 feet high. A central iron core runs through the upper part of the lofty steeple, and carries a weather-vane. Three uneven horizontal cracks have split the upper 8 eet or so into three portions. The uppermost portion still encircles the iron core, the middle portion has, as far as could be judged from below, taken the place of the lowest portion, which has been thrown down towards the S. E. The middle portion has been much shaken about and now rests a little to the N. of the core. The indicator of the weather-vane has been twisted round through 45°, so that the N. pointer points towards the N.E. The central steeple is the only part which has suffered.

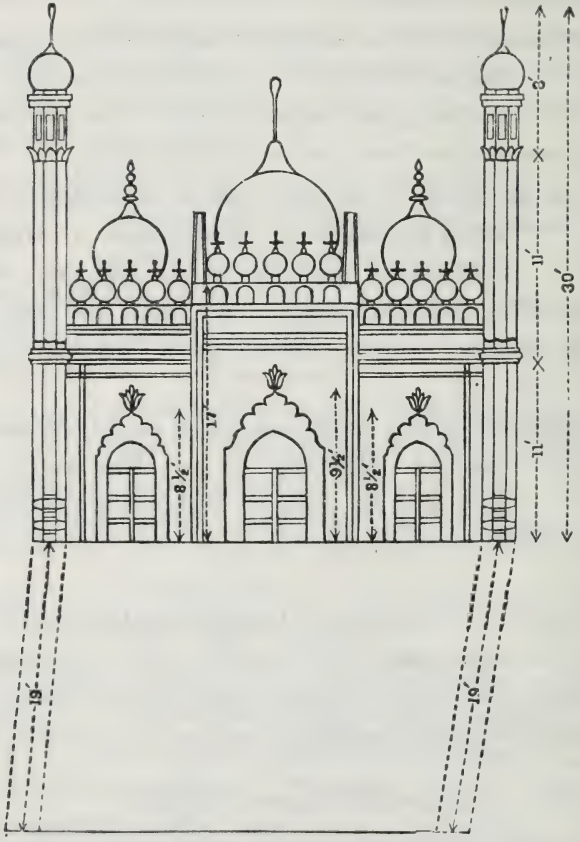
FIG. 44.

Mr. G. W. Maflin, Assistant Engineer.—Time 6-5 by watch. Two chief shocks and then tremulous vibrations for 2 minutes. First shock W.—E., 2nd shock S.—N. He gives an excellent elevation sketch of a mosque the minarets of which fell. (See fig. 44.) Booming sound during vibrations.

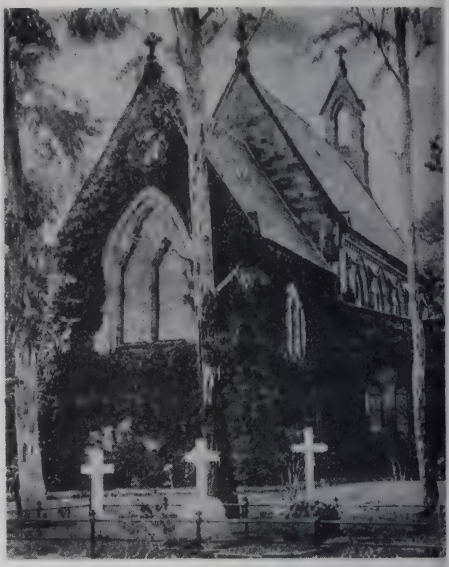
DHARMSALA AND PALAMPUR CHURCHES, BEFORE THE EARTHQUAKE.

The church (see pl. 10, figs. 2 and 3)[1] had the arches on the north side of the central aisle all down, whilst those of the south side were standing. The west end of the church (which had only a small bell-tower) was much broken, and the east end remained as depicted in pl. 10, fig. 3. It should be noted that the steep cliff down into the Maul Khad was in the near
